HYGEIA INC.

REPORT AND RECOMMENDATIONS OF THE SURVEY FOR ASBESTOS AND PCB-CONTAINING MATERIALS AT THE PROPOSED COMMONWEALTH CENTER DEVELOPMENT SITE, WASHINGTON STREET, BOSTON, MASSACHUSETTS

VOLUME ONE  
SURVEY REPORT OF  
ASBESTOS AND PCB-CONTAINING MATERIALS  
COMMONWEALTH CENTER DEVELOPMENT SITE  
BOSTON, MASSACHUSETTS

May 31, 1989

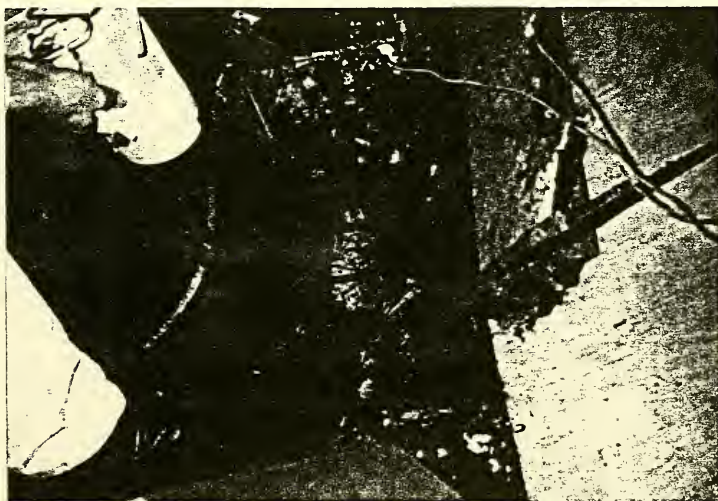
#1: View into pipe chase below tunnel from St. Francis House to Boiler Room

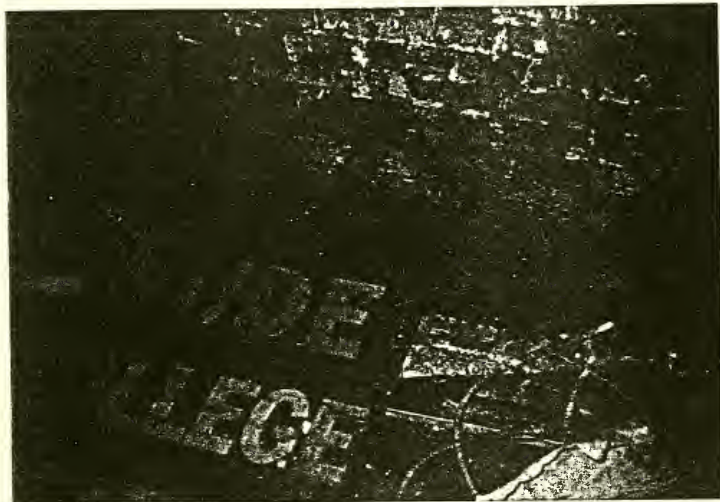
#2: View into pipe chase below tunnel from St. Francis House to Boiler Room

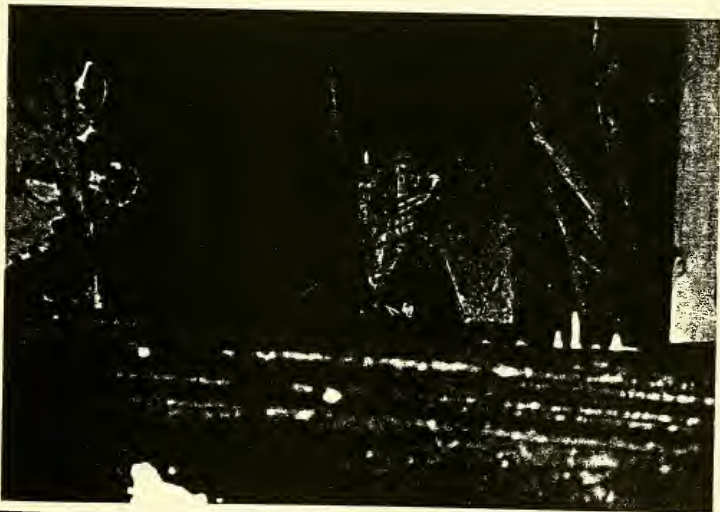
#9: Contaminated debris and demolished insulated ductwork on floor - basement of first floor lounge

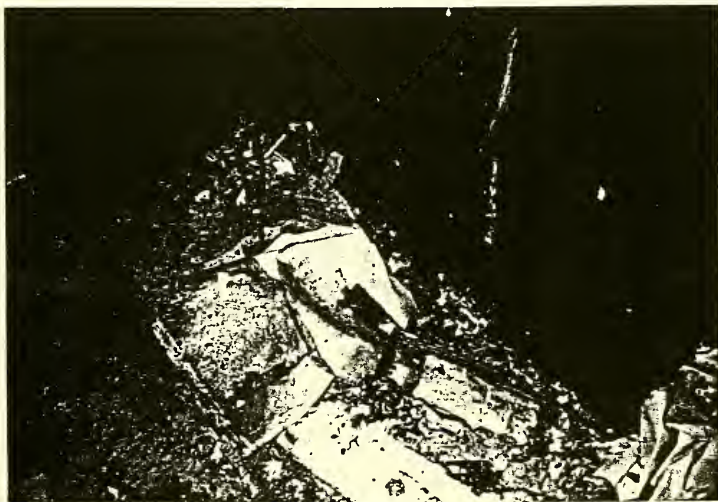
#11: Contaminated debris - basement of first floor lounge

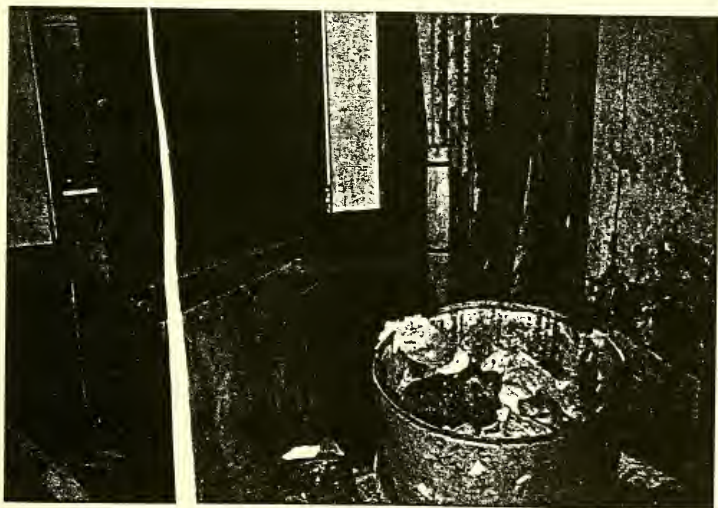
#27: Contaminated debris - basement

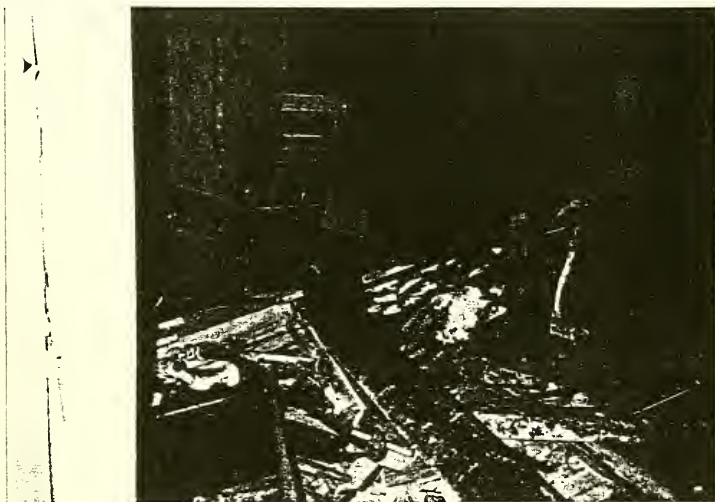
#28: Contaminated debris - basement

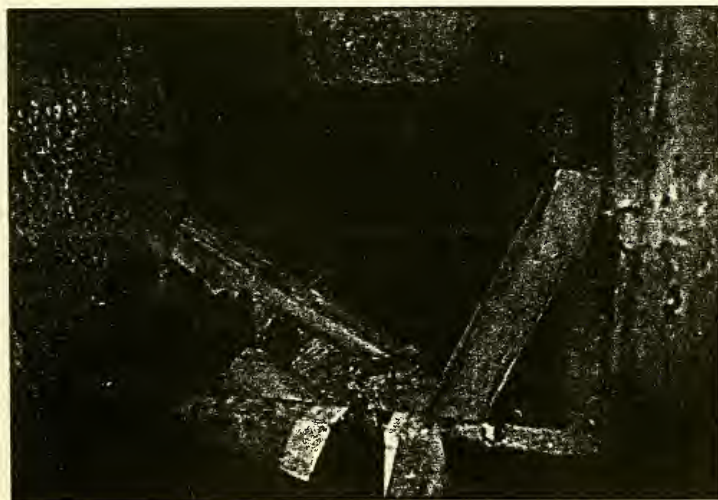
#35: Contaminated debris - basement

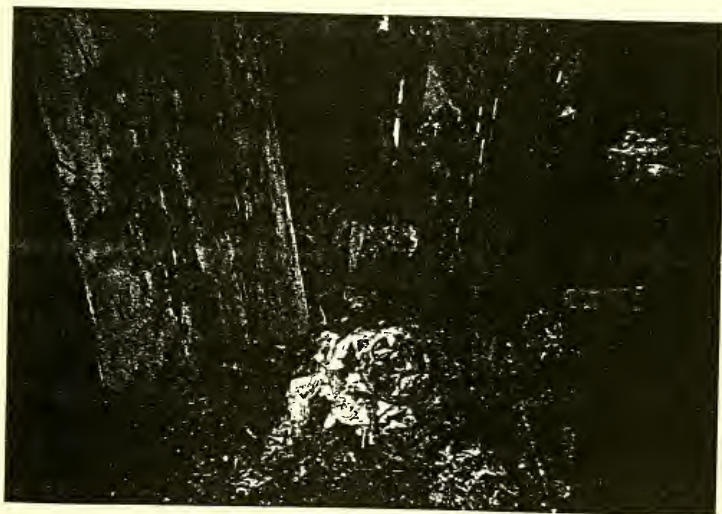
#37: Contaminated debris - basement

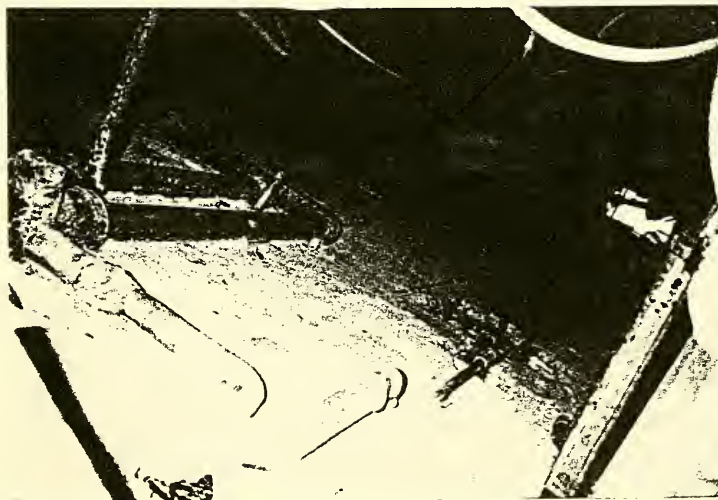
On all floors (2-11), asbestos-containing pipe insulation was observed in chases between each floor. Within these chases, this material has remained in fairly good condition (See Pictures No. 46-49)

#49: View along chase between second floor ceiling and third floor floor

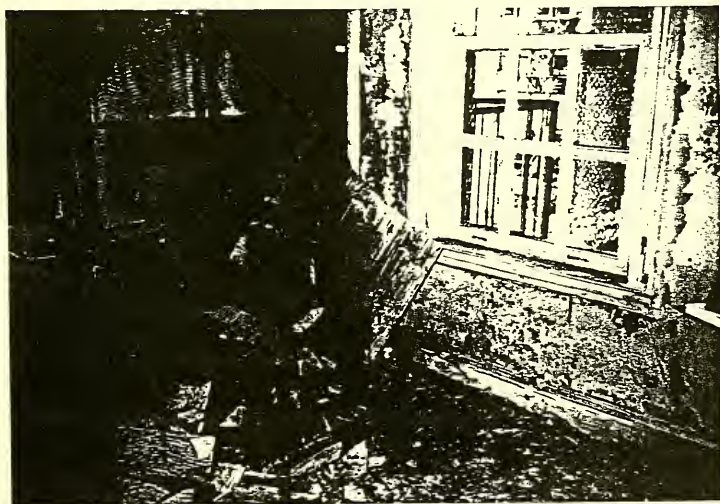
In Rooms 311, 411, 511, ..... 1011, severely damaged pipe insulation was found between the bathroom and main room wall. In most cases, the wall had completely collapsed, spreading debris on the floor of each room (See Picture Nos. 52-54).

#53: Collapsed chase wall - back section Avery

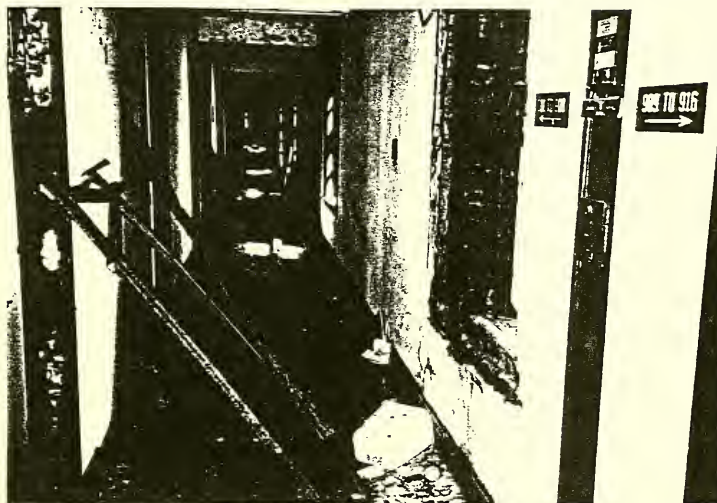
#54: Collapsed chase wall - back section Avery

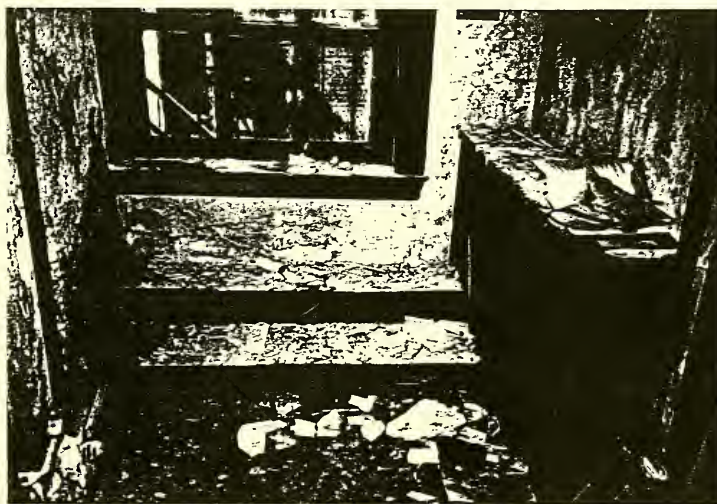
#55: View of contaminated debris in hall - ninth floor

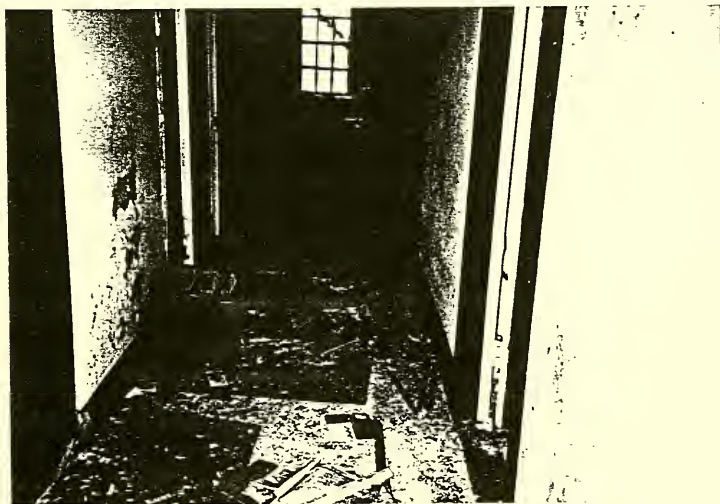
#57: Contaminated debris - ninth floor

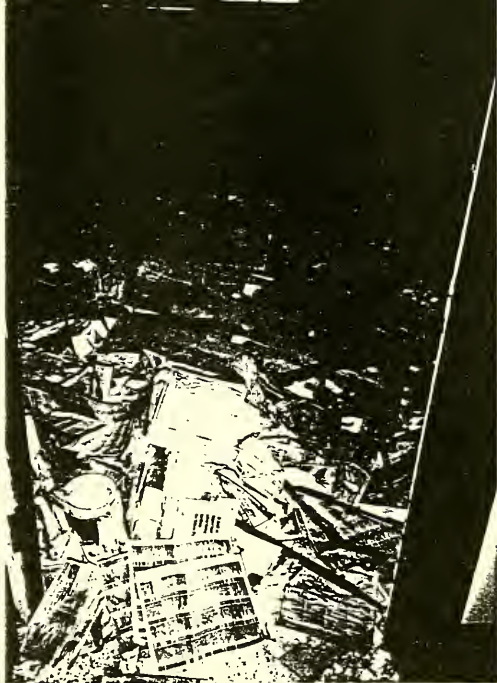
#58: Contaminated debris - ninth floor
